KD469.22

Assembly/disassembly recommendations

TOYOTA: Avensis, Avensis verso, Corolla, Corolla verso, Picnic, Previa, RAV4	ENGINES 2.0 D4-D	OE REFERENCE See below
--	---------------------	---------------------------

TIMING KINEMATICS OF THE KIT KD469.22

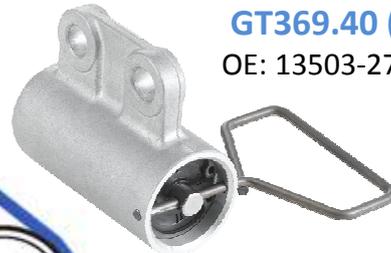
GT369.26 (T1)

OE: 13505-27010

GT369.40 (T2)

OE: 13503-27010

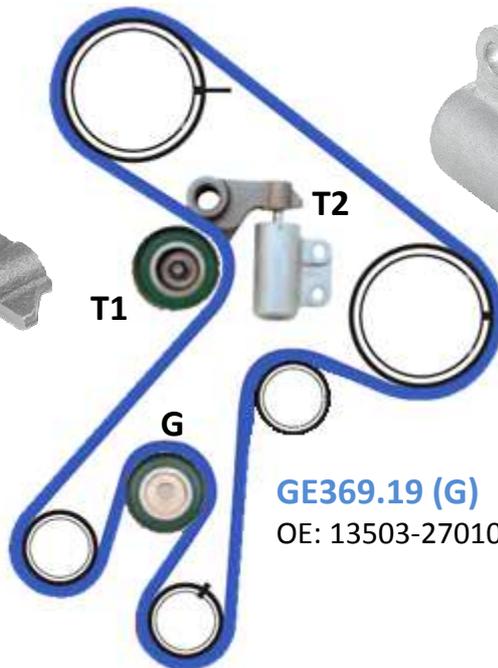
T1

T2

G

BELT WITH TEETH

178 teeth

OE: 13568-29035

GE369.19 (G)

OE: 13503-27010

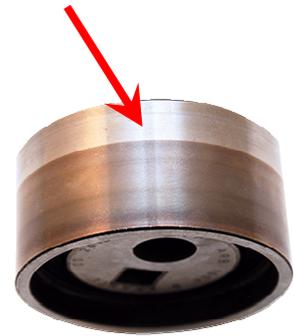
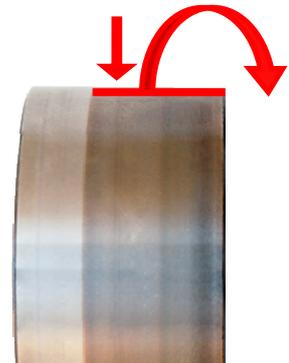
1) BAD BELT POSITIONING

Probable causes

- Misalignment of timing components or component wear
- Non-standard belt tension
- Roller tensioner GT369.26 not attached correctly

Consequences

Belt slippage

Improper positioning of the belt may result in a misalignment of the load leading to abnormal bearing running. This anomaly affects other components of the timing system and can lead to in the short-term a seizure of bearings with balls being ejected.

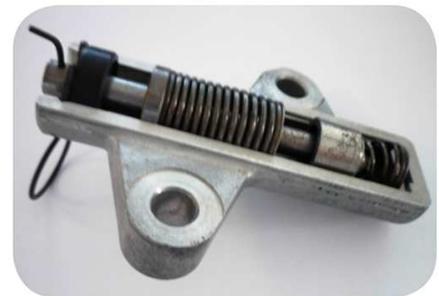
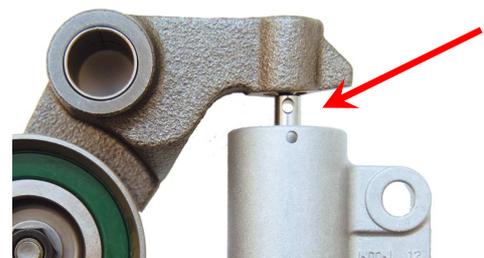
2) MALFUNCTION OF HYDRAULIC TENSIONER

Loss of oil in the damper rod.

Air infiltration in the oil that can lead to a lack of damping and therefore jumps or destruction of teeth.

Damage to the hydraulic tensioner body.

Consequences

The hydraulic tensioner no longer ensures belt tension, nor its course.

In effect it controls the dynamics of the belt, it maintains its constant tension and compensates for changes in length due to temperature changes.

It is imperative to change the hydraulic tensioner as it plays a fundamental role.

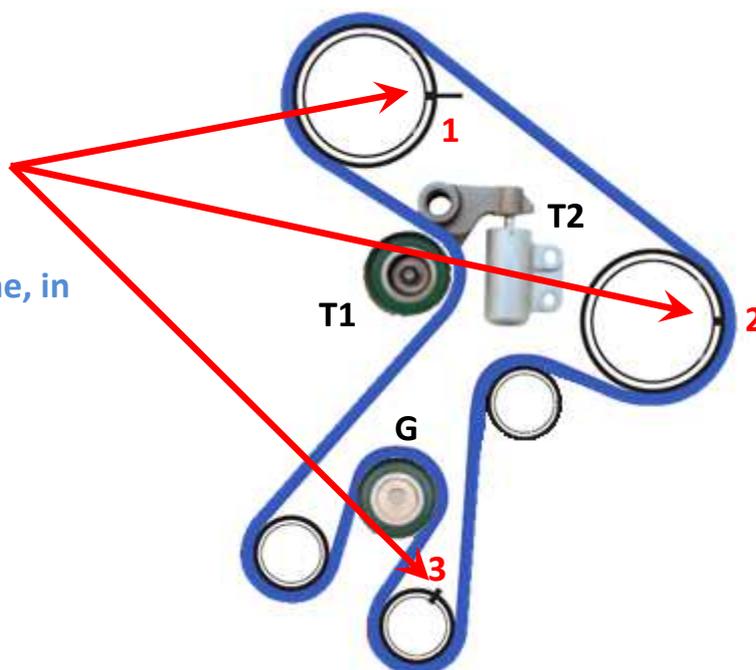
4) Fit the timing belt, with a cold engine, in the following order:

- Camshaft sprocket
- High pressure pump sprocket
- Water pump sprocket
- Crankshaft sprocket
- Pulley → G (GE369.19)
- Oil pump sprocket
- Roller tensioner → T1 (GT369.26)

Make sure the belt is tensioned on the side where there is no roller tensioner

3) Make sure the timing marks are aligned (1, 2 and 3)

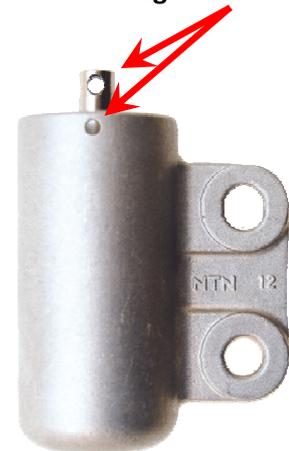
alignment

In case of early unpinning: How to reposition the locking pin on the hydraulic tensioner?

- Slowly compress the piston into the body of the hydraulic tensioner using a press until the holes are aligned.
This operation must be carried out in a vertical position.

Do not exceed a force of 1000 kg.

- Hold the piston in place by inserting the correct locking pin through the hole in the body of the hydraulic tensioner.
