| Climate Control | Blower Motor Resistors | Premature Failure | All

Failing blower motor regulators

Short circuit shortly after replacement

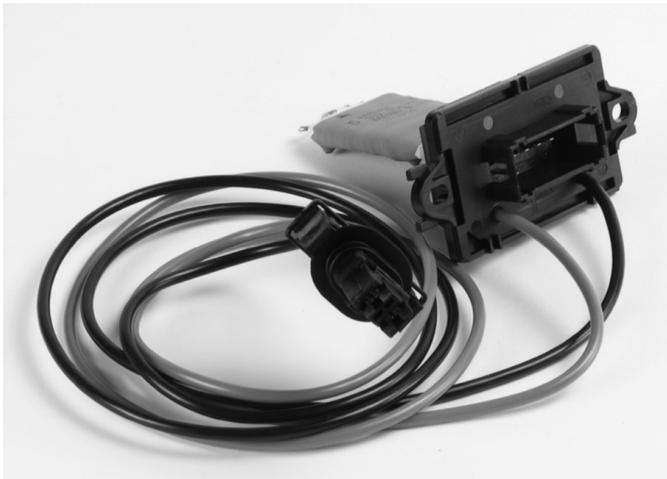
Valeo's warranty department regularly sees heater blower motor regulators come in, for which people claim it failed prematurely, shortly after installation. The regulators have had internal short circuit, so consequently the blower motor is no longer actuated.

Replace the complete blower motor at the time the regulator breaks down.

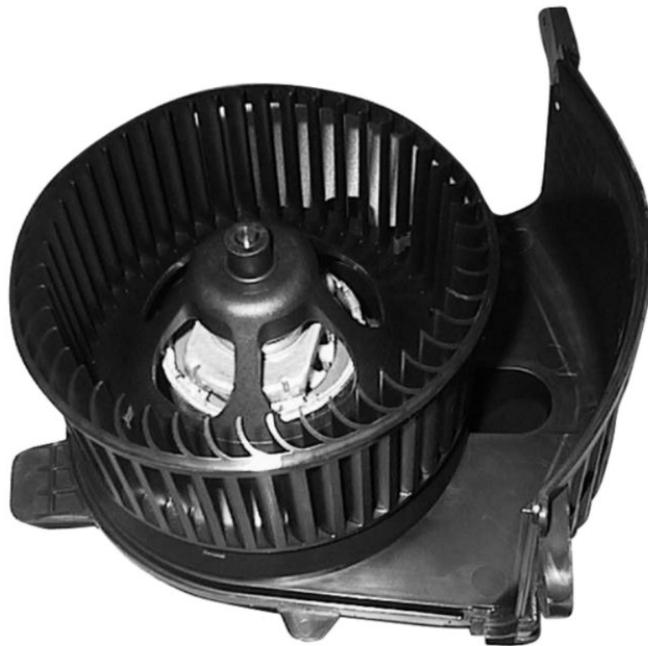
If the blower motor itself is rotating (more) heavily (think of moisture ingress and/or damaged or worn bearings), the electrical motor needs to deliver more force in order to overcome the extra resistance/friction.

Only replacing the regulator and leaving in the old (damaged) blower motor, will overload the new regulator in the same way it did the old, causing it to break down prematurely.
